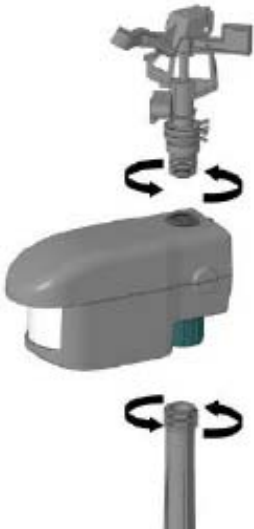
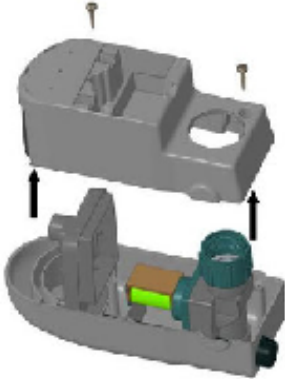
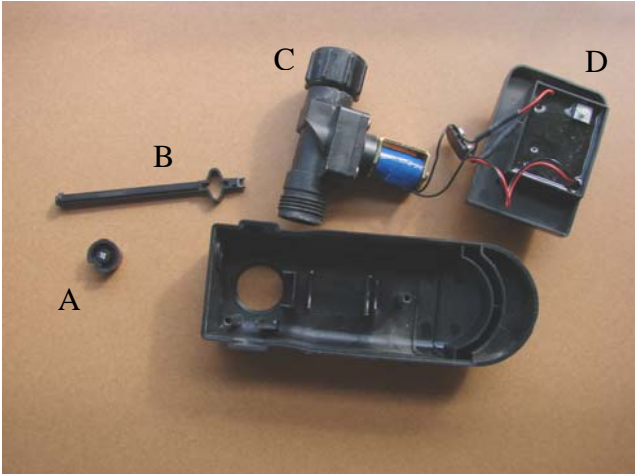
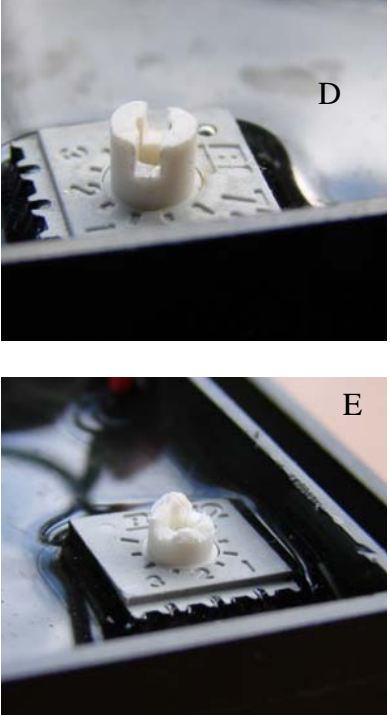
Step One	Step Two	Step Three	Step Four

<p>Remove the sprinkler head and stake. (Unscrew by turning counter-clockwise).</p>	<p>Turn the ScareCrow head upside down. Open the ScareCrow unit by removing the two Phillips head screws. Open gently.</p>	<p>Remove the broken sensitivity knob (A) and rod (B) , the solenoid/valve unit (C), and the sensor unit (D).</p>	<p>Inspect the white sensitivity dial on the sensor head, it should be intact (like in photo D) if any part of the dial has broken off (like in photo E) replacing the sensitivity rod will not fix the problem.</p>

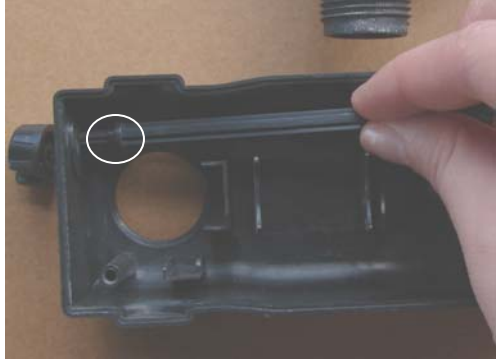
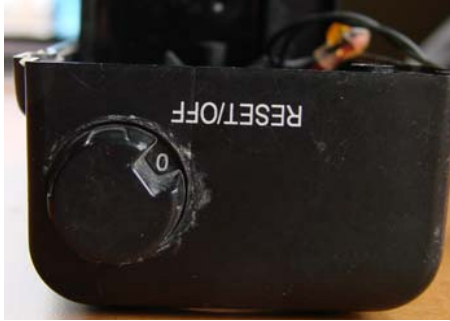
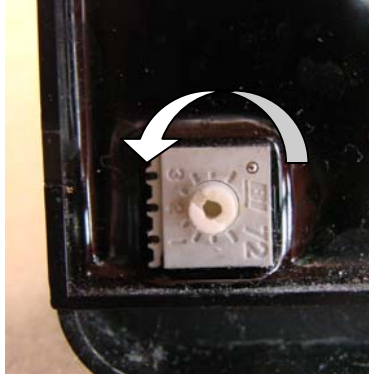
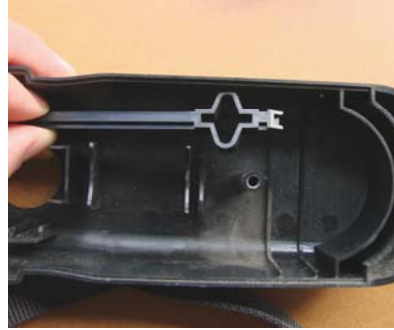
Step 5	Step 6	Step 7	Step 8

<p>Insert the new Sensitivity Rod and attach it to the new sensitivity knob. Press firmly and insure that the sensitivity rod is inserted until the ridge circled in the photo is flush with the ScareCrow's casing.</p>	<p>Rotate the sensitivity knob to zero.</p>	<p>Using the tip of your fingernail, gently rotate the white dial on the sensor counter-clockwise until it won't go any further.</p>	<p>Gently lift up on the sensitivity rod so that the tip is in line with the edge of the scarecrow casing.</p>

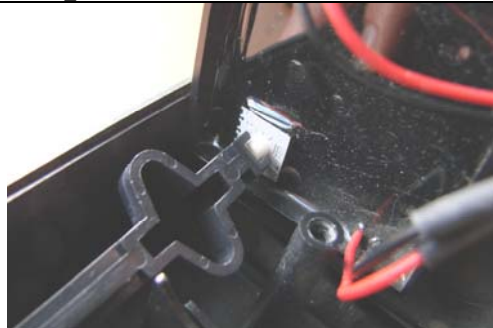
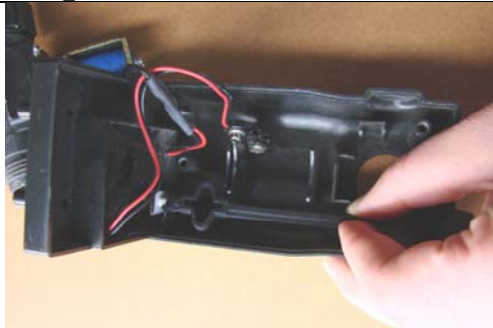
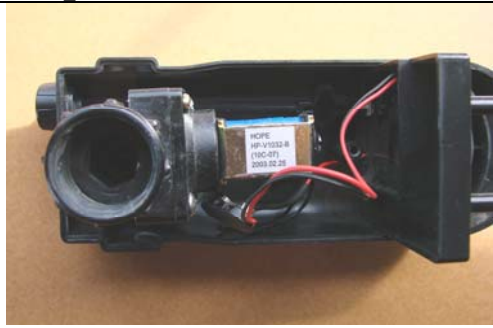
Step Nine	Step Ten	Step Eleven

<p>Pick up the sensor head and fit the sensitivity rod into the slot on the sensor's white dial.</p>	<p>Re-insert the sensor head unit fully.</p>	<p>Place the Solenoid/Valve assembly back into it cradle (please make sure the writing on the solenoid is facing up). Reassemble unit.</p>
